NEEDS ASSESSMENT

PHILOMATH FIRE & RESCUE

Fire Station # 201

2150358.01

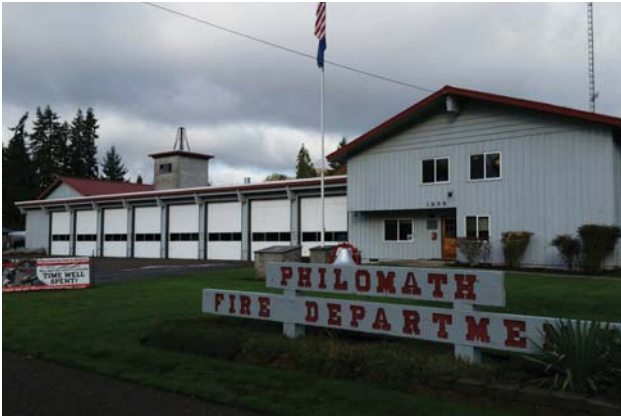
1. PUBLIC ENTRY

- No 911 vestibule
- No public seating or waiting area

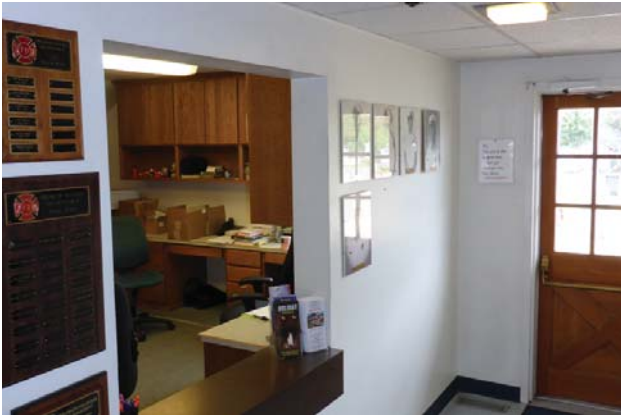
2. RECEPTION AREA OFFICE

- INADEQUATE IN SIZE FOR FULL TIME STAFF
- LIMIT CAPACITY FOR STORAGE AND FUTURE GROWTH

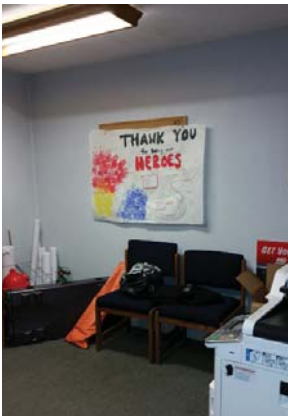
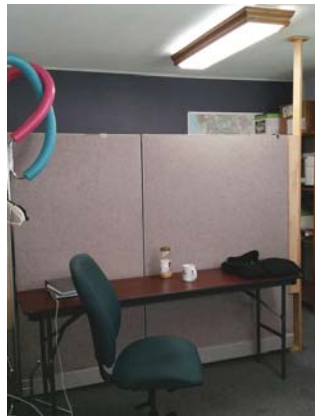
3, 4. CONFERENCE REPURPOSED AS 2 OFFICES

- OFFICES SERVE MULTIPLE FUNCTIONS
- ONE OFFICE SERVES AS OFFICE AND ADMINISTRATIVE WORK AREA W/ COPIER
- ONE OFFICE SERVES AS PANIC ROOM AND OFFICE

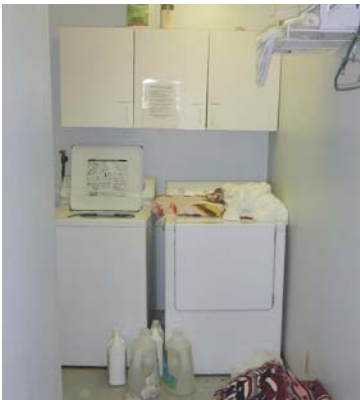
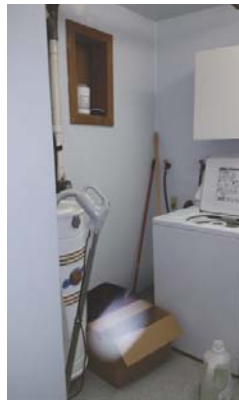
5, 6. LAUNDRY

- LAUNDRY ROOM IS A VERY CONFINED SPACE WITH LIMITED STORAGE OR WORKING SURFACE SPACE

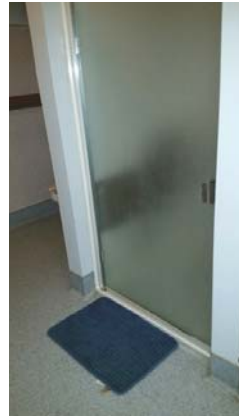
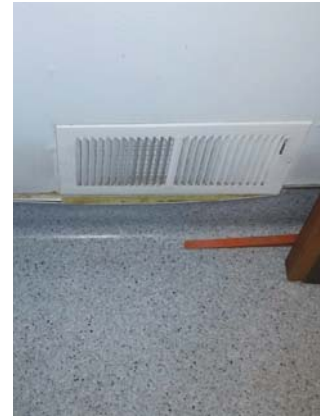
7, 8. WOMENS SHOWER

- DOES NOT MEET CURRENT ADA SHOWER AND ACCESSIBILITY STANDARDS

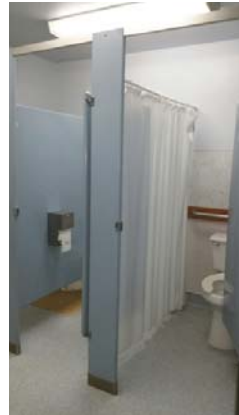
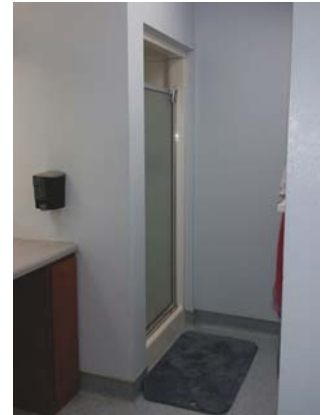
9, 10. MENS SHOWER

- DOES NOT MEET CURRENT ADA SHOWER AND ACCESSIBILITY STANDARDS

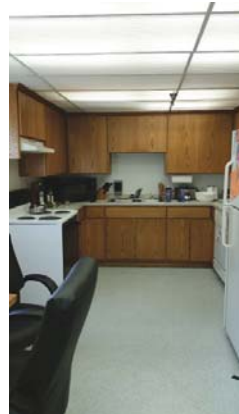
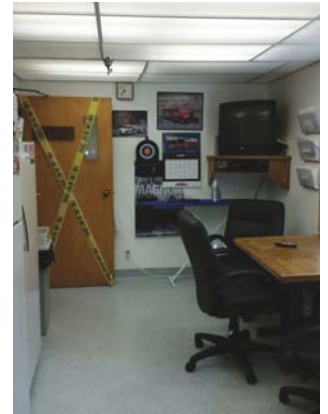
11, 12. KITCHEN - FIRST FLOOR

- CONFINED EXISTING KITCHEN THAT DOES NOT MEET CURRENT ADA ACCESSIBILITY STANDARDS
- CABINETRY, APPLIANCES AND FINISHES ARE NEAR END OF USEFUL LIFE.

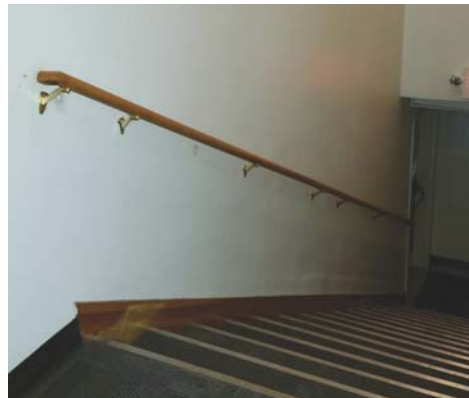
13. STAIRS

- NO ADA ACCESS TO SECOND FLOOR
- NON ADA COMPLIANT HANDRAILS

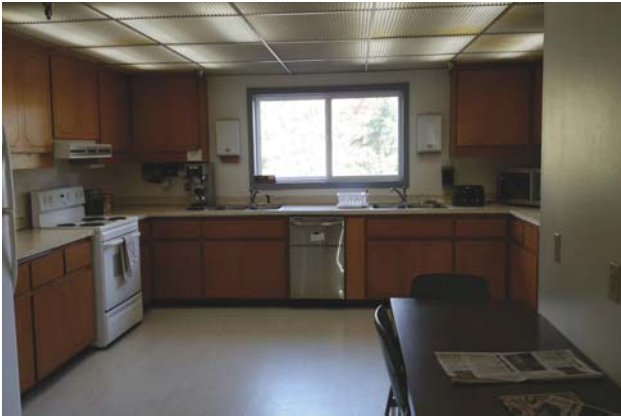
14. KITCHEN - SECOND FLOOR

- KITCHEN FACILITIES DO NOT MEET ADA ACCESSIBILITY STANDARDS. CORRECTLY NEXT TO MEETING ROOM THAT IS NOT ACCESSIBLE TO PUBLIC.
- CABINETRY, APPLIANCES AND FINISHES ARE NEAR END OF USEFUL LIFE.

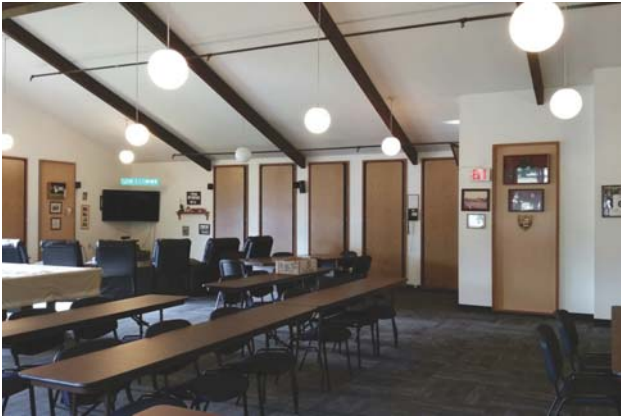
15. MEETING ROOM

- EXISTING MEETING ROOM SERVES AS MULTIPURPOSE ROOM THAT IS USED TO OVERLAP FACILITY OPERATION USE, SERVES AS MEETING ROOM, DAY ROOM, STORAGE AND OFFICE AREA.
- SUSPENDED LIGHTING NOT SEISMICALLY BRACED.

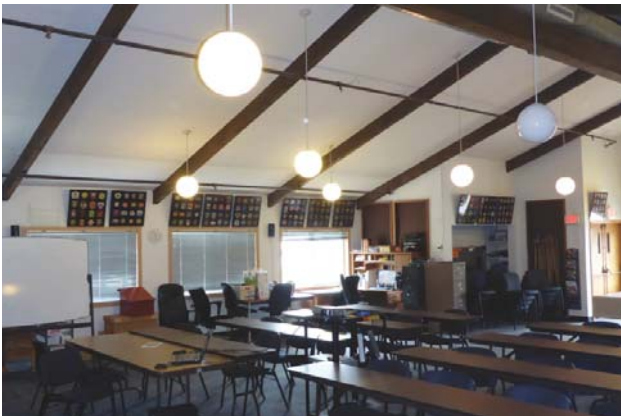
16. MEETING ROOM

- LACK OF STORAGE DUE TO COMBINING OVERLAP OF FACILITY PROGRAM USE

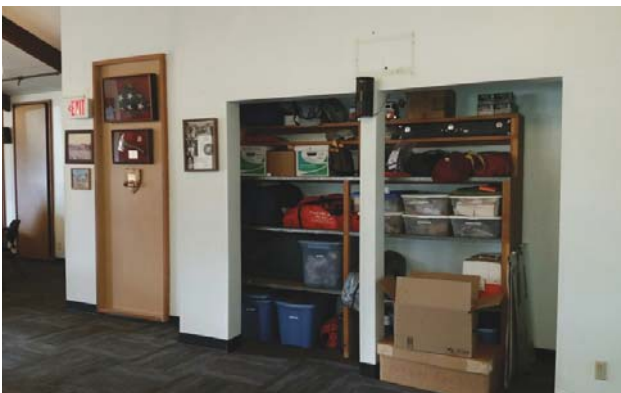
17. MEETING ROOM

- LACK OF STORAGE DUE TO COMBINING OVERLAP OF FACILITY PROGRAM USE

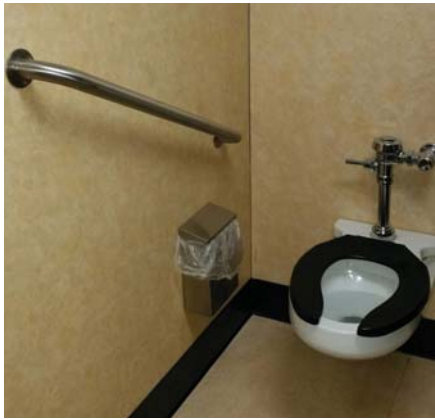
18. WOMENS RESTROOM

- COUNTERTOP DOES NOT MEET ADA CODE REQUIREMENTS
- FINISHES IN FAIR CONDITIONS, HOWEVER ARE BEGINING TO DEMONSTRATE AGE AND SHOULD CONSIDER UPDATING

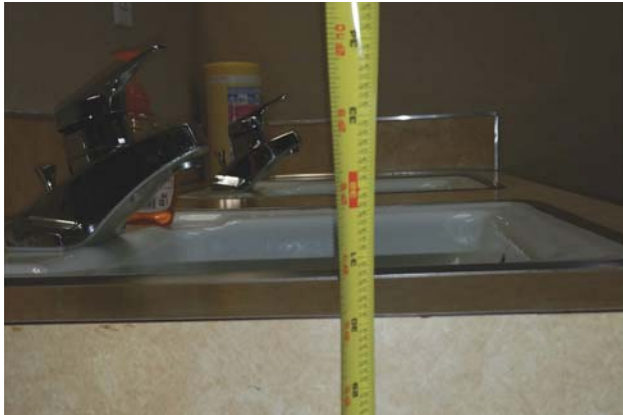
19. MENS RESTROOM

- COUNTERTOP DOES NOT MEET ADA CODE REQUIREMENTS
- FINISHES IN FAIR CONDITIONS, HOWEVER ARE BEGINING TO DEMONSTRATE AGE AND SHOULD CONSIDER UPDATING

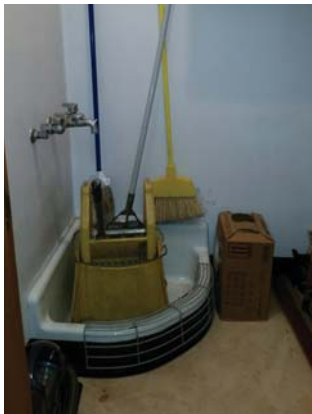
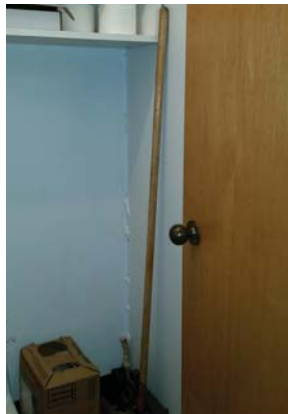
20, 21. JANITOR ROOM

- LOCATION IS NOT IDEAL OR CENTRALLY LOCATED
- POSSIBLE MOISTURE, GYPSUM BOARD TAPE IS BUBBLING AT CORNER

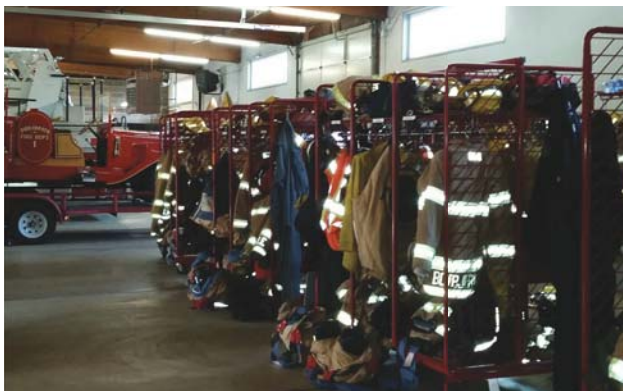
22. APPARATUS BAY

- TURN OUT GEAR EXPOSED TO UV LIGHT

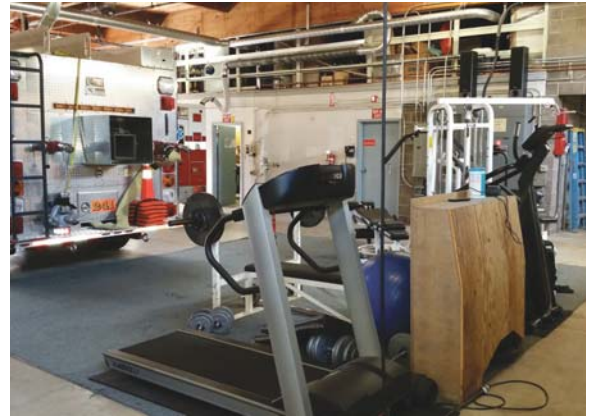
23. PHYSICAL TRAINING

- LOCATED IN APPARATUS BAY
- UNCONDITIONED SPACE SUBJECT TO TEMPERATURE FLUCTUATIONS.
- INADEQUATE SPACE TO USE AS WORKOUT AREA. FACILITY LACKS PROPER SPACE FOR ACTUAL DESIGNATED WORKOUT ROOM.

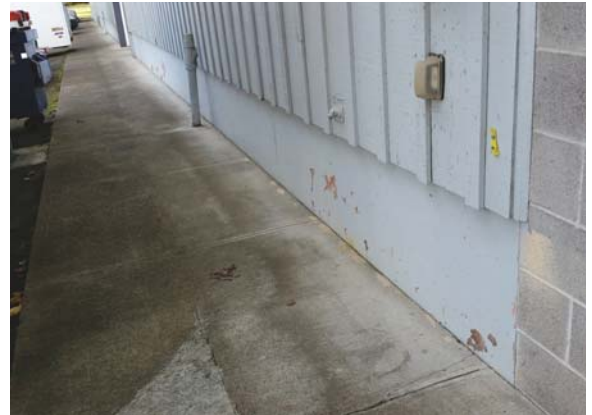
24. EXTERIOR - NORTH

Though currently serviceable, the existing building siding appears to show significant signs of weathering and is likely nearing the end of its' useful life. There are a number of areas where the paint has flaked off leaving the siding exposed to the elements and creating spots of significant water damage. Flashing has begun to fail due to its' age and further impacted the condition of the exterior siding at grade level and around select openings. Of particular concern are the west and south walls of the Annex, built as an addition to the existing structure in 2005. At these locations significant water damage was observed and should be monitored to ensure that bacteria does not develop within the material.

- EXTERIOR PAINT IS FLAKING OFF SIDING AND CONCRETE. RECOMMEND NEW EXTERIOR PAINT.
- SIDING MATERIAL NEARING END OF USEFUL LIFE.

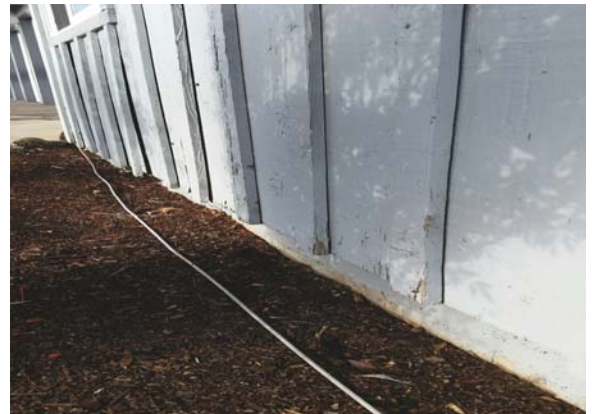
25. EXTERIOR - SOUTH

- EXTERIOR PAINT IS FLAKING OFF SIDING AND CONCRETE. RECOMMEND NEW EXTERIOR PAINT.
- SIDING MATERIAL NEARING END OF USEFUL LIFE.

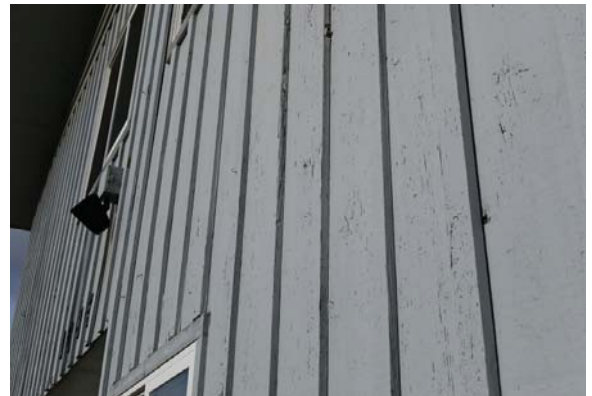
26. EXTERIOR - SOUTH

- EXTERIOR PAINT IS FLAKING OFF SIDING AND CONCRETE. RECOMMEND NEW EXTERIOR PAINT
- SIDING MATERIAL NEARING END OF USEFUL LIFE.

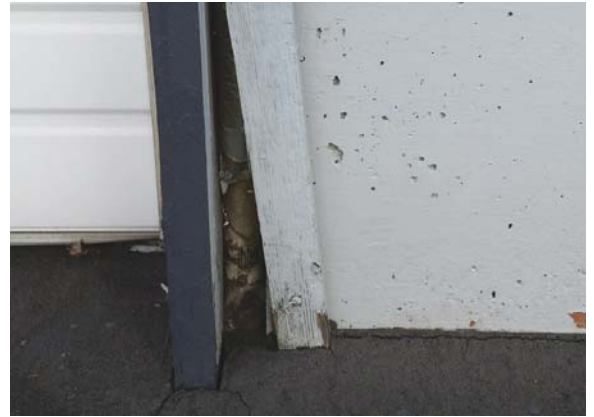
27. EXTERIOR - SOUTH

- INSULATION IS EXPOSED, CREATING POSSIBLE CONDITION FOR MOISTURE PENETRATION AND POSSIBLE GROWTH OF MOLD

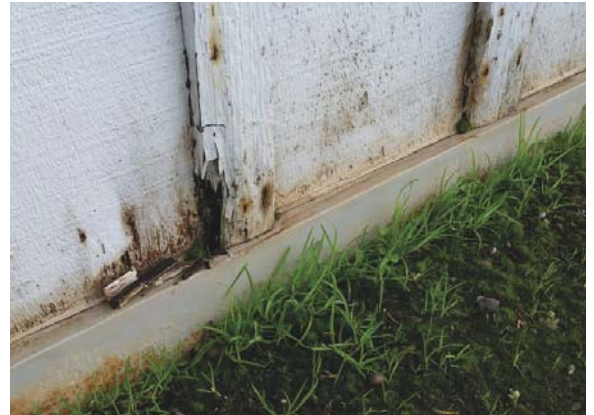
28. EXTERIOR - WEST

- EXTERIOR PAINT IS FLAKING OFF SIDING AND CONCRETE. RECOMMEND NEW EXTERIOR PAINT.
- EXCESS MOISTURE AND EXTERIOR BOTTOM OF SIDING ROTTING AWAY AND GROWING MUSHROOMS DUE TO EXCESS MOISTURE.

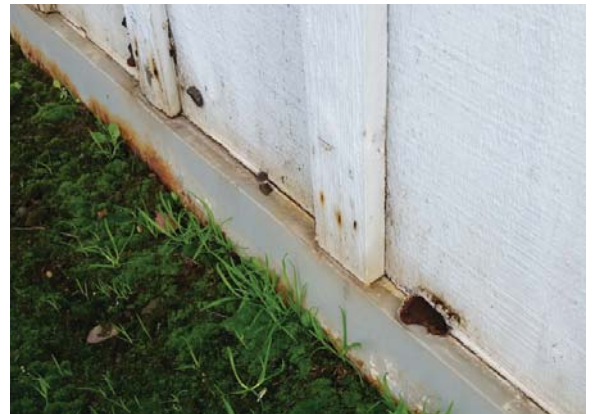
29. EXTERIOR - WEST

- EXTERIOR PAINT IS FLAKING OFF SIDING AND CONCRETE. RECOMMEND NEW EXTERIOR PAINT.
- EXCESS MOISTURE AND EXTERIOR BOTTOM OF SIDING ROTTING AWAY AND GROWING OF FUNGUS DUE TO EXCESS MOISTURE.

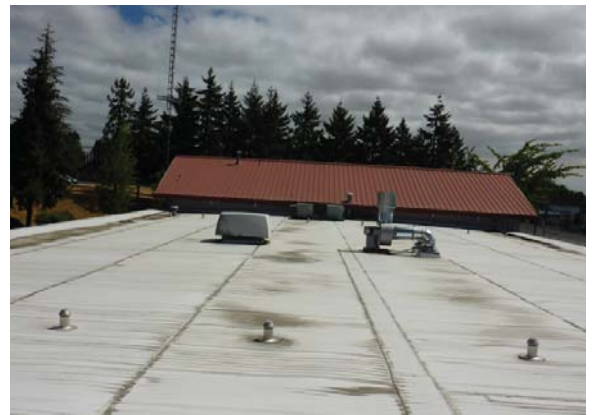
30. ROOF

The existing roof appears to be in serviceable condition, but should be evaluated further moving forward to confirm that it condition, and that of the storm water drainage system, is suitable.

- APPEARS TO STILL BE IN GOOD TO FAIR CONDITION. RECOMMEND FURTHER EVALUATION TO CONFIRM DRAINAGE SYSTEM IS ACCEPTABLE.

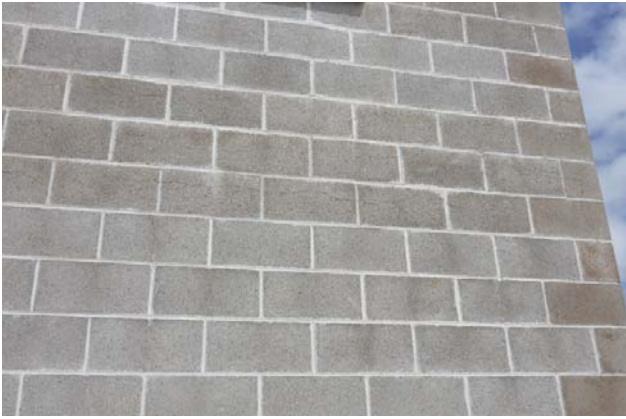
31. TOWER

- CRACK AT EXISTING CMU BLOCK OF TOWER (MOISTURE) PROBLEM.

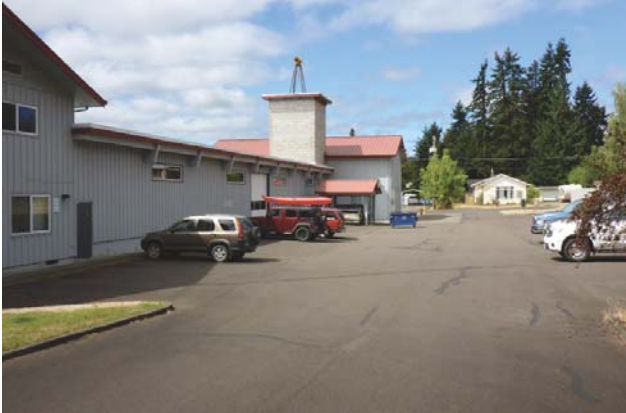
32. EXTERIOR - NORTH

- PARKING SPACES NOT CLEARLY DEFINED
- NEW STRIPING

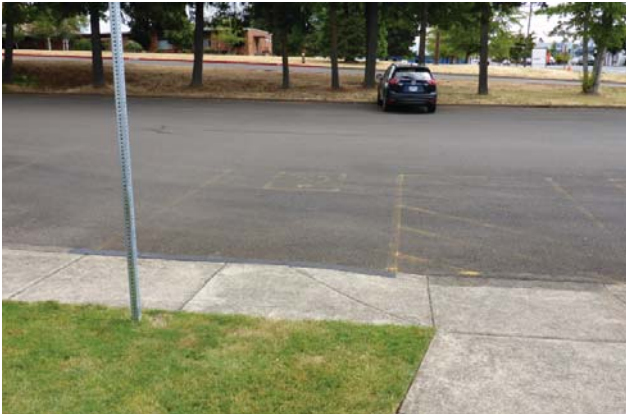
33. EAST PARKING (PUBLIC)

- PARKING SPACES NOT CLEARLY DEFINED
- NEW STRIPING

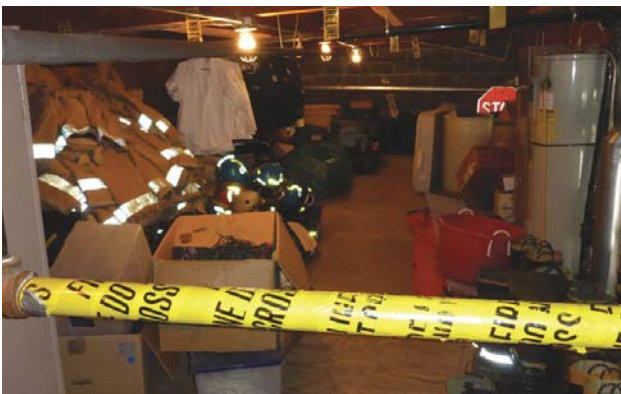
34. STORAGE MEZZANINE

- OVER CROWDED MEZZANINE USED FOR STORAGE DUE TO LIMITED STORAGE CAPACITY IN APPARATUS BAY.

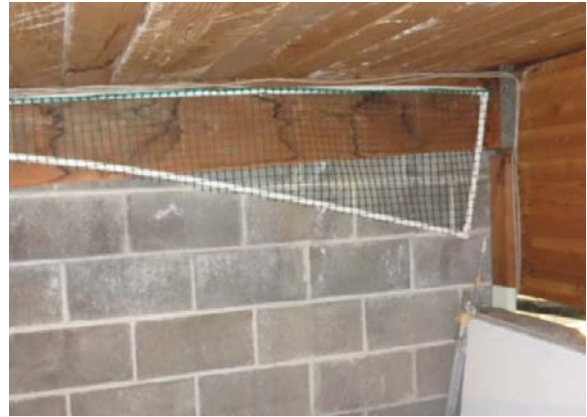
35. STORAGE MEZZANINE - BEAM WATER DAMAGE

- WATER STAINING ON BEAM, FLOOR FRAMING SYSTEM SUGGEST WATER AND MOISTURE PENETRATION IN THIS AREA. FURTHER INVESTIGATION IS RECOMMENDED TO IDENTIFY SOURCE OF POSSIBLE INTRUSION.
