NEEDS ASSESSMENT

PHILOMATH FIRE & RESCUE

Fire Station # 201

2150358.01

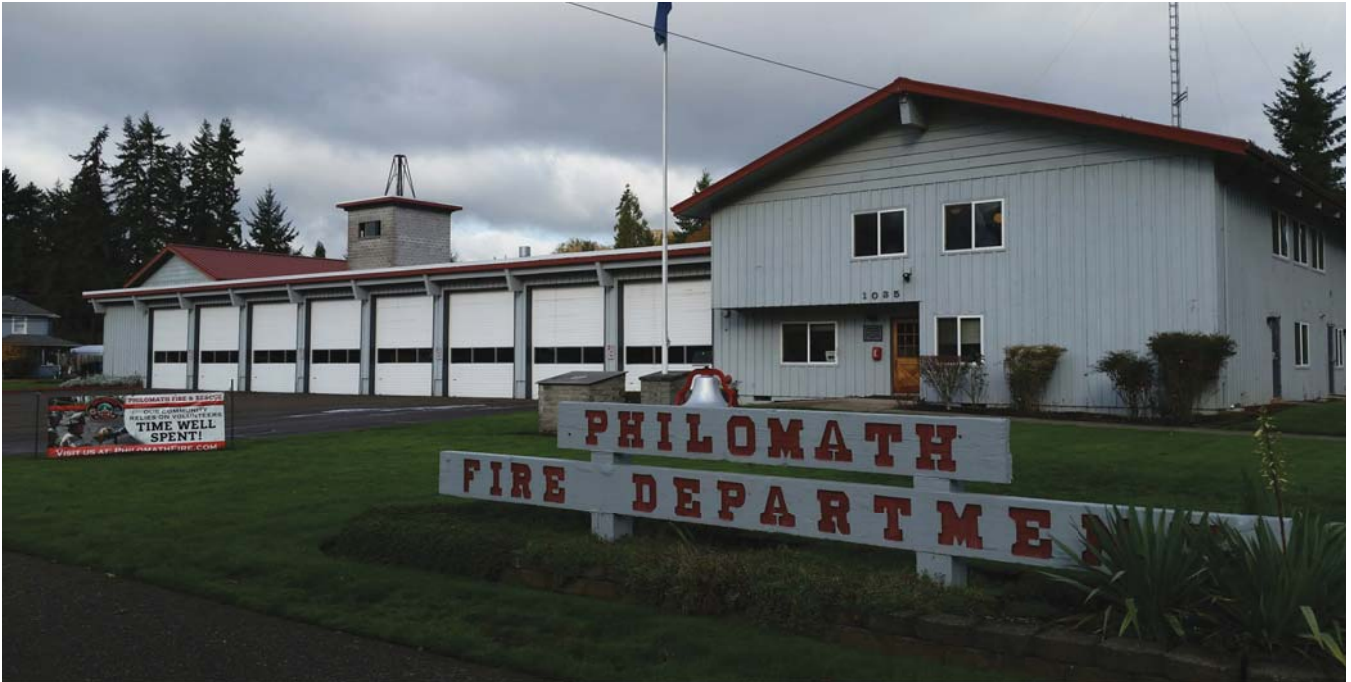
VIEW OF FIRE STATION 201 (FROM SOUTHEAST ON MAIN STREET)

Though currently serviceable, the existing building siding appears to show significant signs of weathering and is likely nearing the end of its' useful life. There are a number of areas where the paint has flaked off leaving the siding exposed to the elements and creating spots of significant water damage. Flashing has begun to fail due to its' age and further impacted the condition of the exterior siding at grade level and around select openings. Of particular concern are the west and south walls of the Annex, built as an addition to the existing structure in 2005. At these locations significant water damage was observed and should be monitored to ensure that bacteria does not develop within the material.
